No. 1410.—NORTH PACIFIC OCEAN, SANDWICH ISLANDS—MAUI.

Kahului Harbour—Light Established.

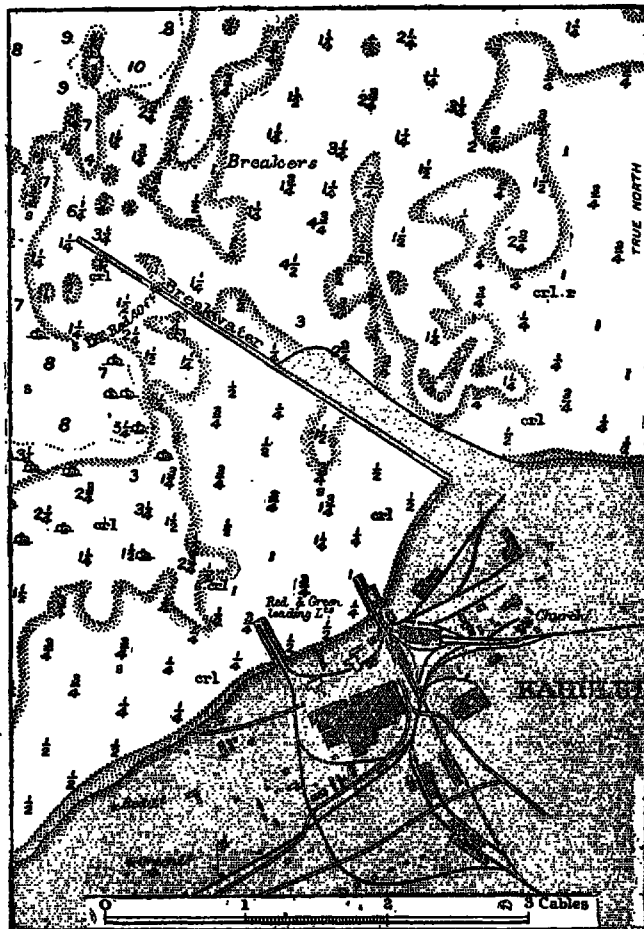
Position.—On new breakwater, at a distance of about 400 feet within its outer extremity, latitude- $20^{\circ} 54' N.$, long. $156^{\circ} 28\frac{1}{4}' W.$

Character.—A fixed red light.

Elevation.—40 feet.

Remarks.—The position of this light, and the new breakwater are shown on the accompanying reproduction of a portion of plan No. 3534.
